Taj is not symmetrical, discover city researchers

By Mihika BasuMihika Basu, Bangalore Mirror Bureau | Mar 25, 2016, 04.00 AM IST

Nias scholars say the central dome is tilted from vertical axis
Wise men say there's no such thing as perfect love. Even the ultimate Indian emblem of love, the Taj Mahal — known for its perfect symmetry and flawless architecture — has its flaws. Now an interesting research by the National Institute of Advanced Studies (Nias), Bengaluru, shows that the central dome of the monument is slightly askew.

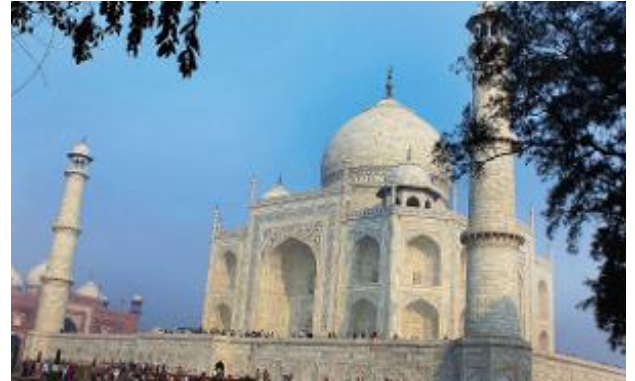
"The main anomaly is that the central dome of the monument is not perfectly symmetrical. The other is relatively minor: in some of the photographs, the finial over the central dome is tilted from the vertical axis. The tilt could have occurred when the bronze replica was installed in the early 19th century, or during a subsequent restoration," says the report.

They took horizontal slices at different heights from the drum (on which the dome sits) and measured the pixels on the right and the left sides. "Since they were unequal, we concluded that the dome is asymmetric," said Ahuja, who has visited the Taj Mahal four times.

For the second conjecture, the paper says, it is becoming apparent that the northern and the southern ends of the platform on which the Taj sits are differentially sinking over time, with the northern end towards the river having sunk 35 mm more than the southern end.

"It is an outer dome constructed after the inner dome was finished and therefore perhaps the builders did not have the benefit of a central plumb line," reveals the paper.
